Nashua Conservation Commission
Wetlands Application

Proposed Fire Training Facility

REPORT ON WETLANDS

Proposed Firefighter Training Area

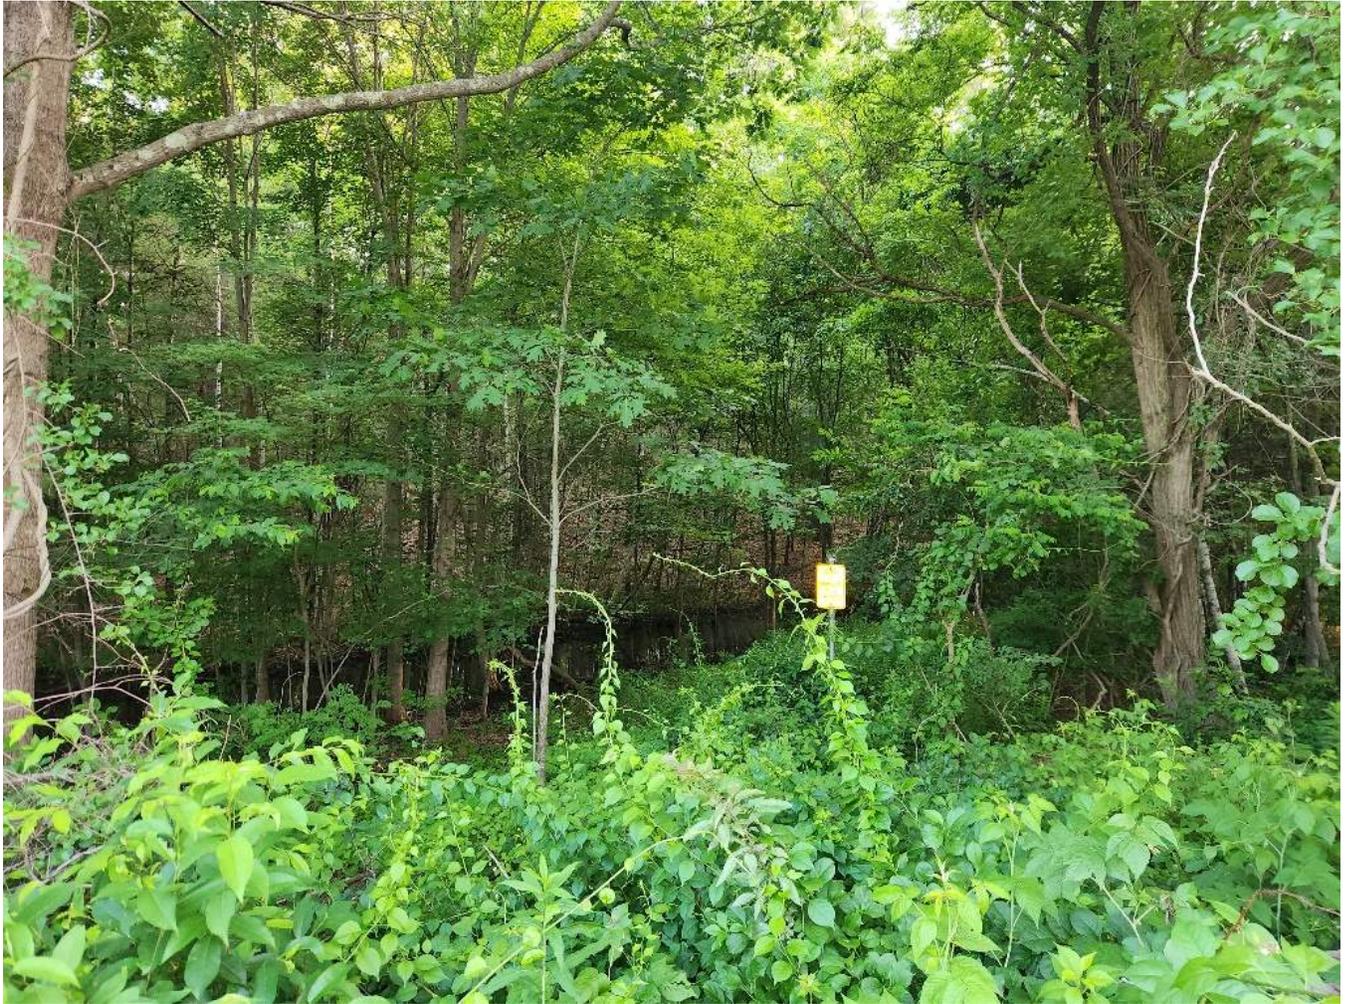
Figure 3: Teak Drive at Gosselin Road intersection facing west at the conveyance channel carrying vernal pool flow north to wetlands in area of proposed access road

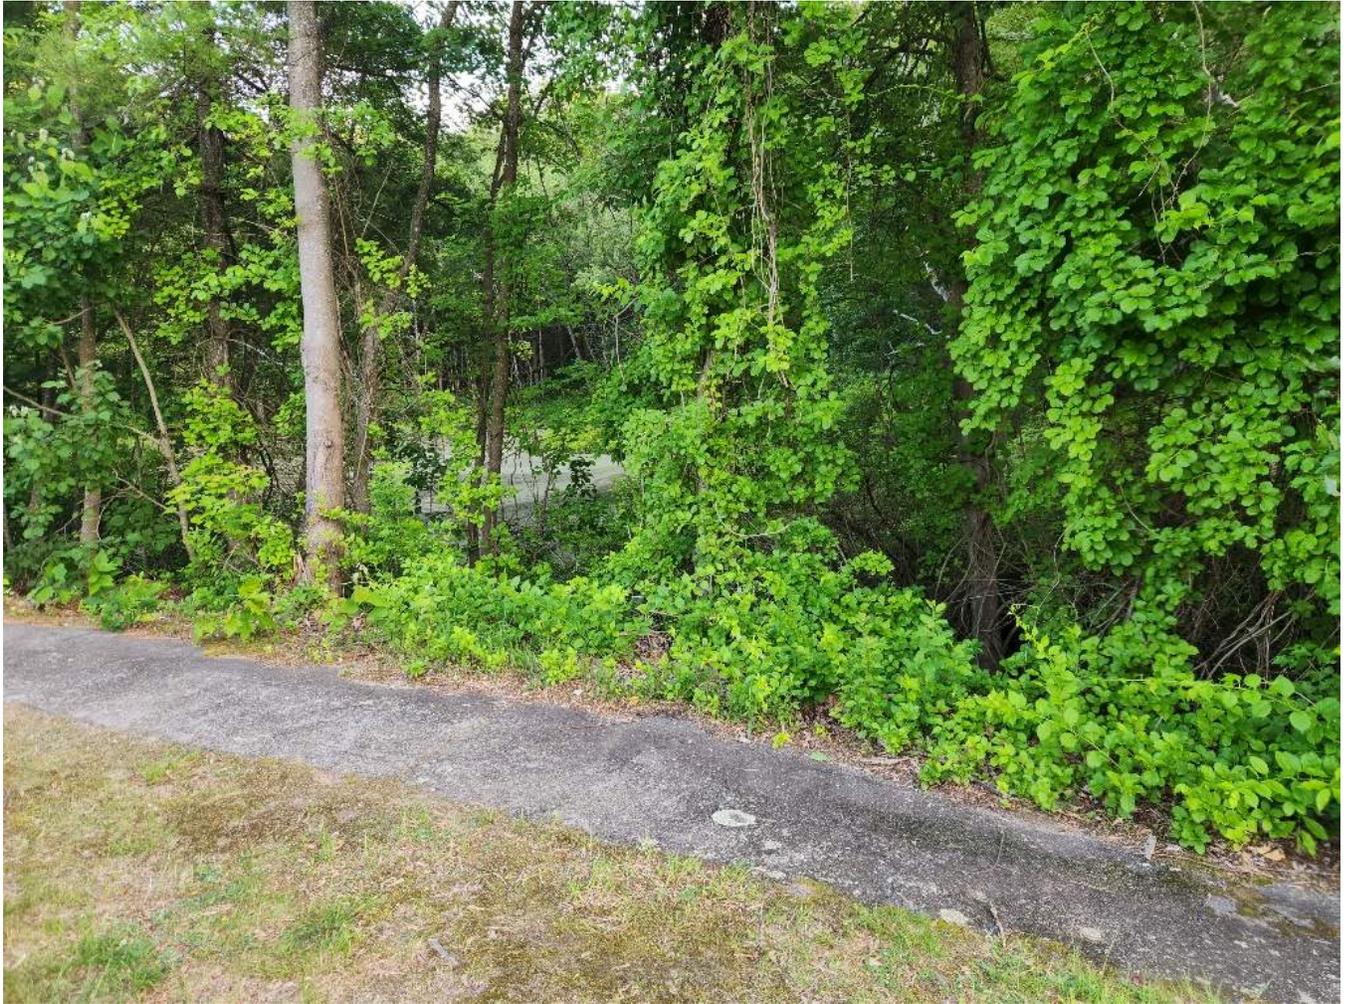
Figure 4: Teak Drive at Gosselin Road intersection facing southwest at the vernal pool

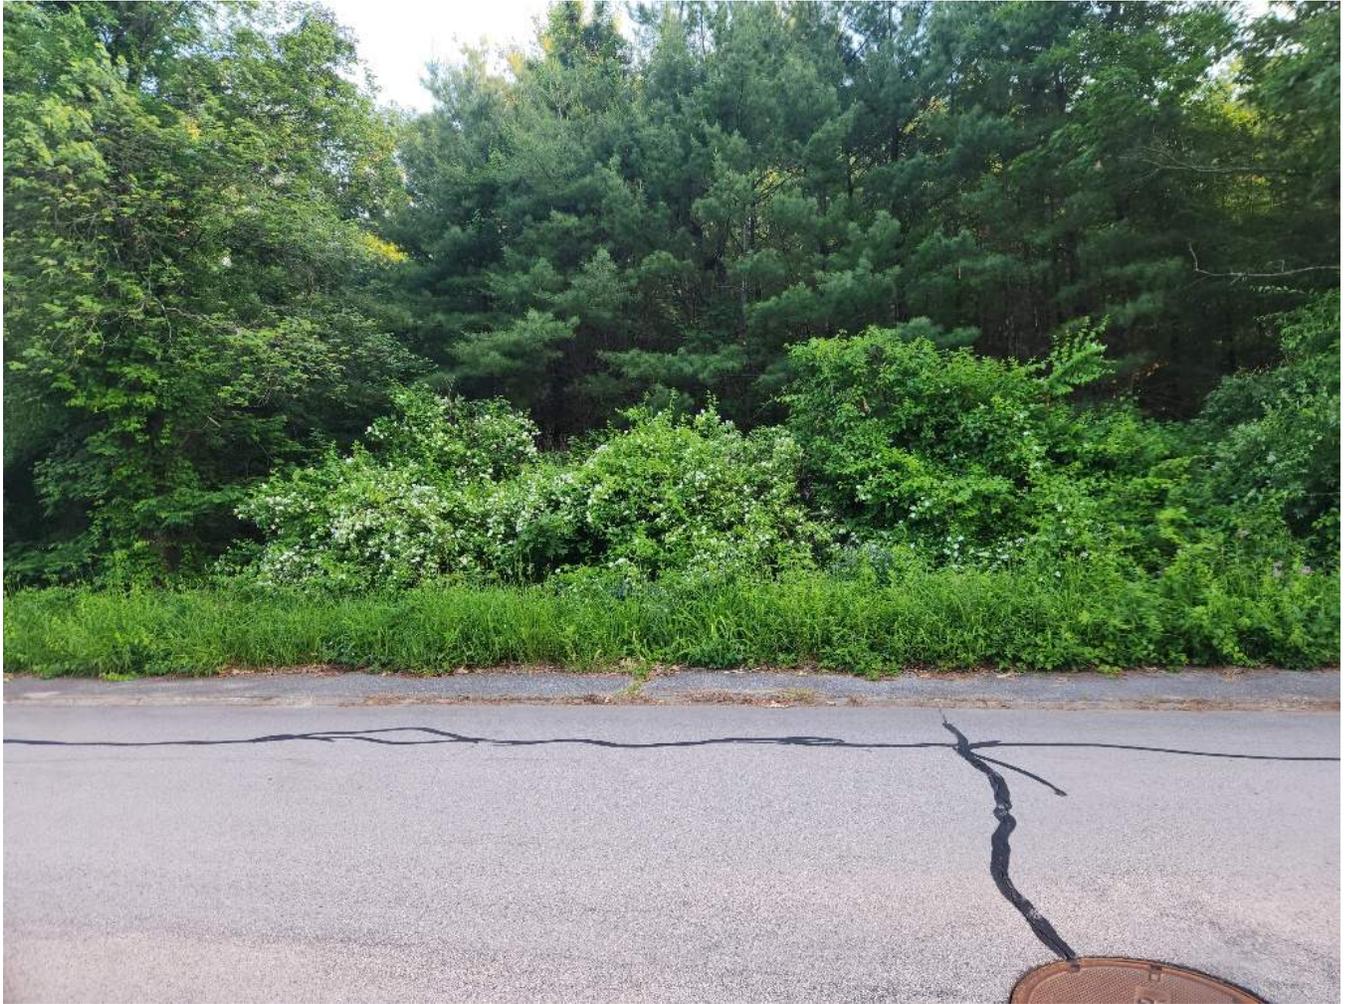
Figure 5: #20 Teak Drive facing west at the existing stormwater basin and north edge of proposed access road

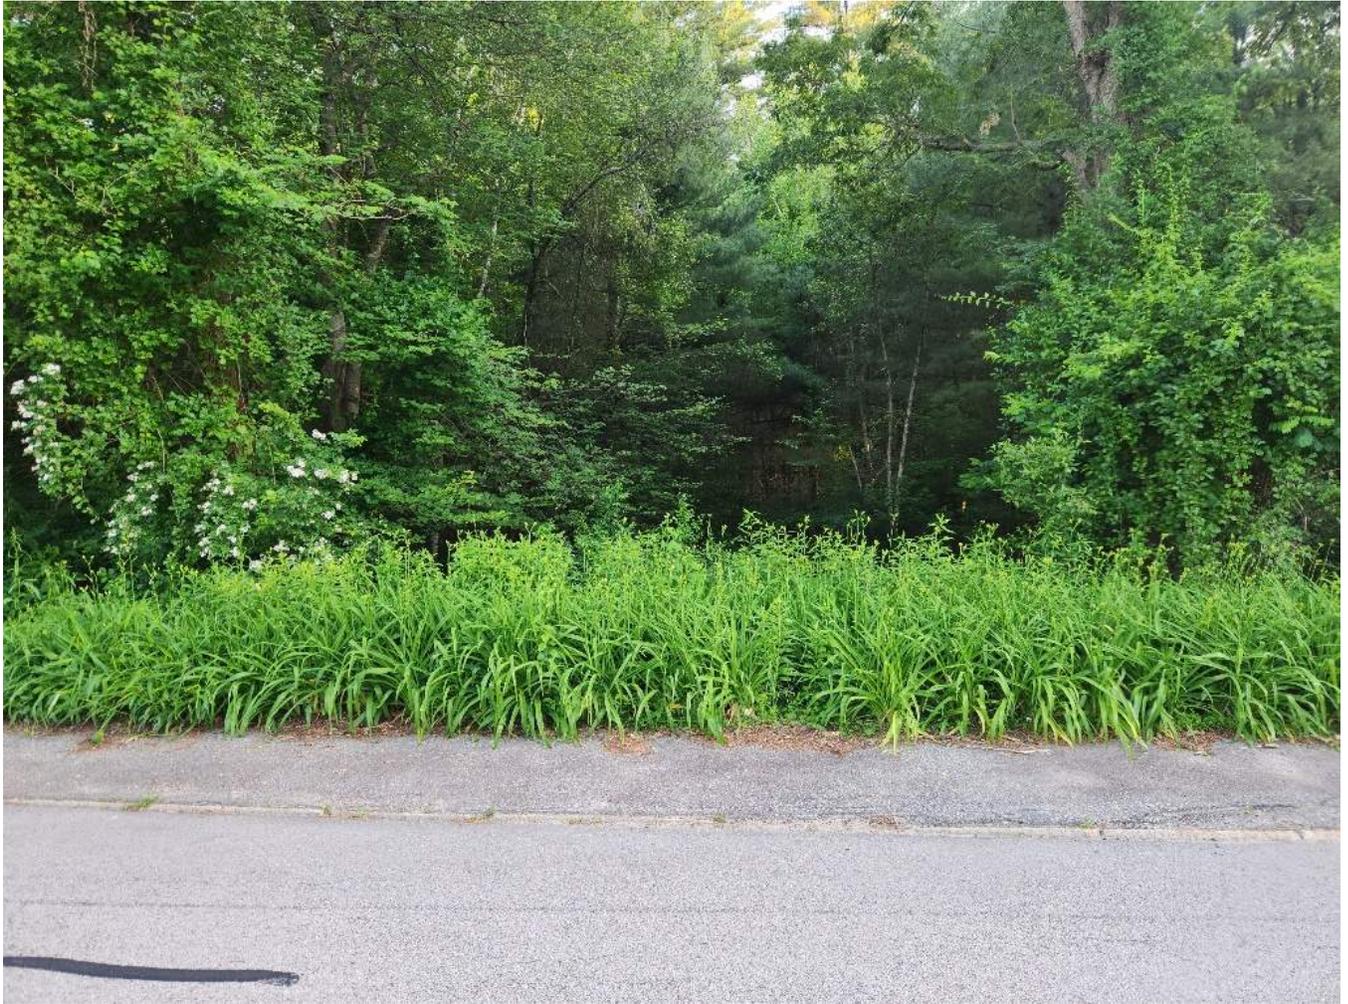
Figure 6: Near property boundary of #22 and #24 Teak Drive facing west at the existing stormwater basin.

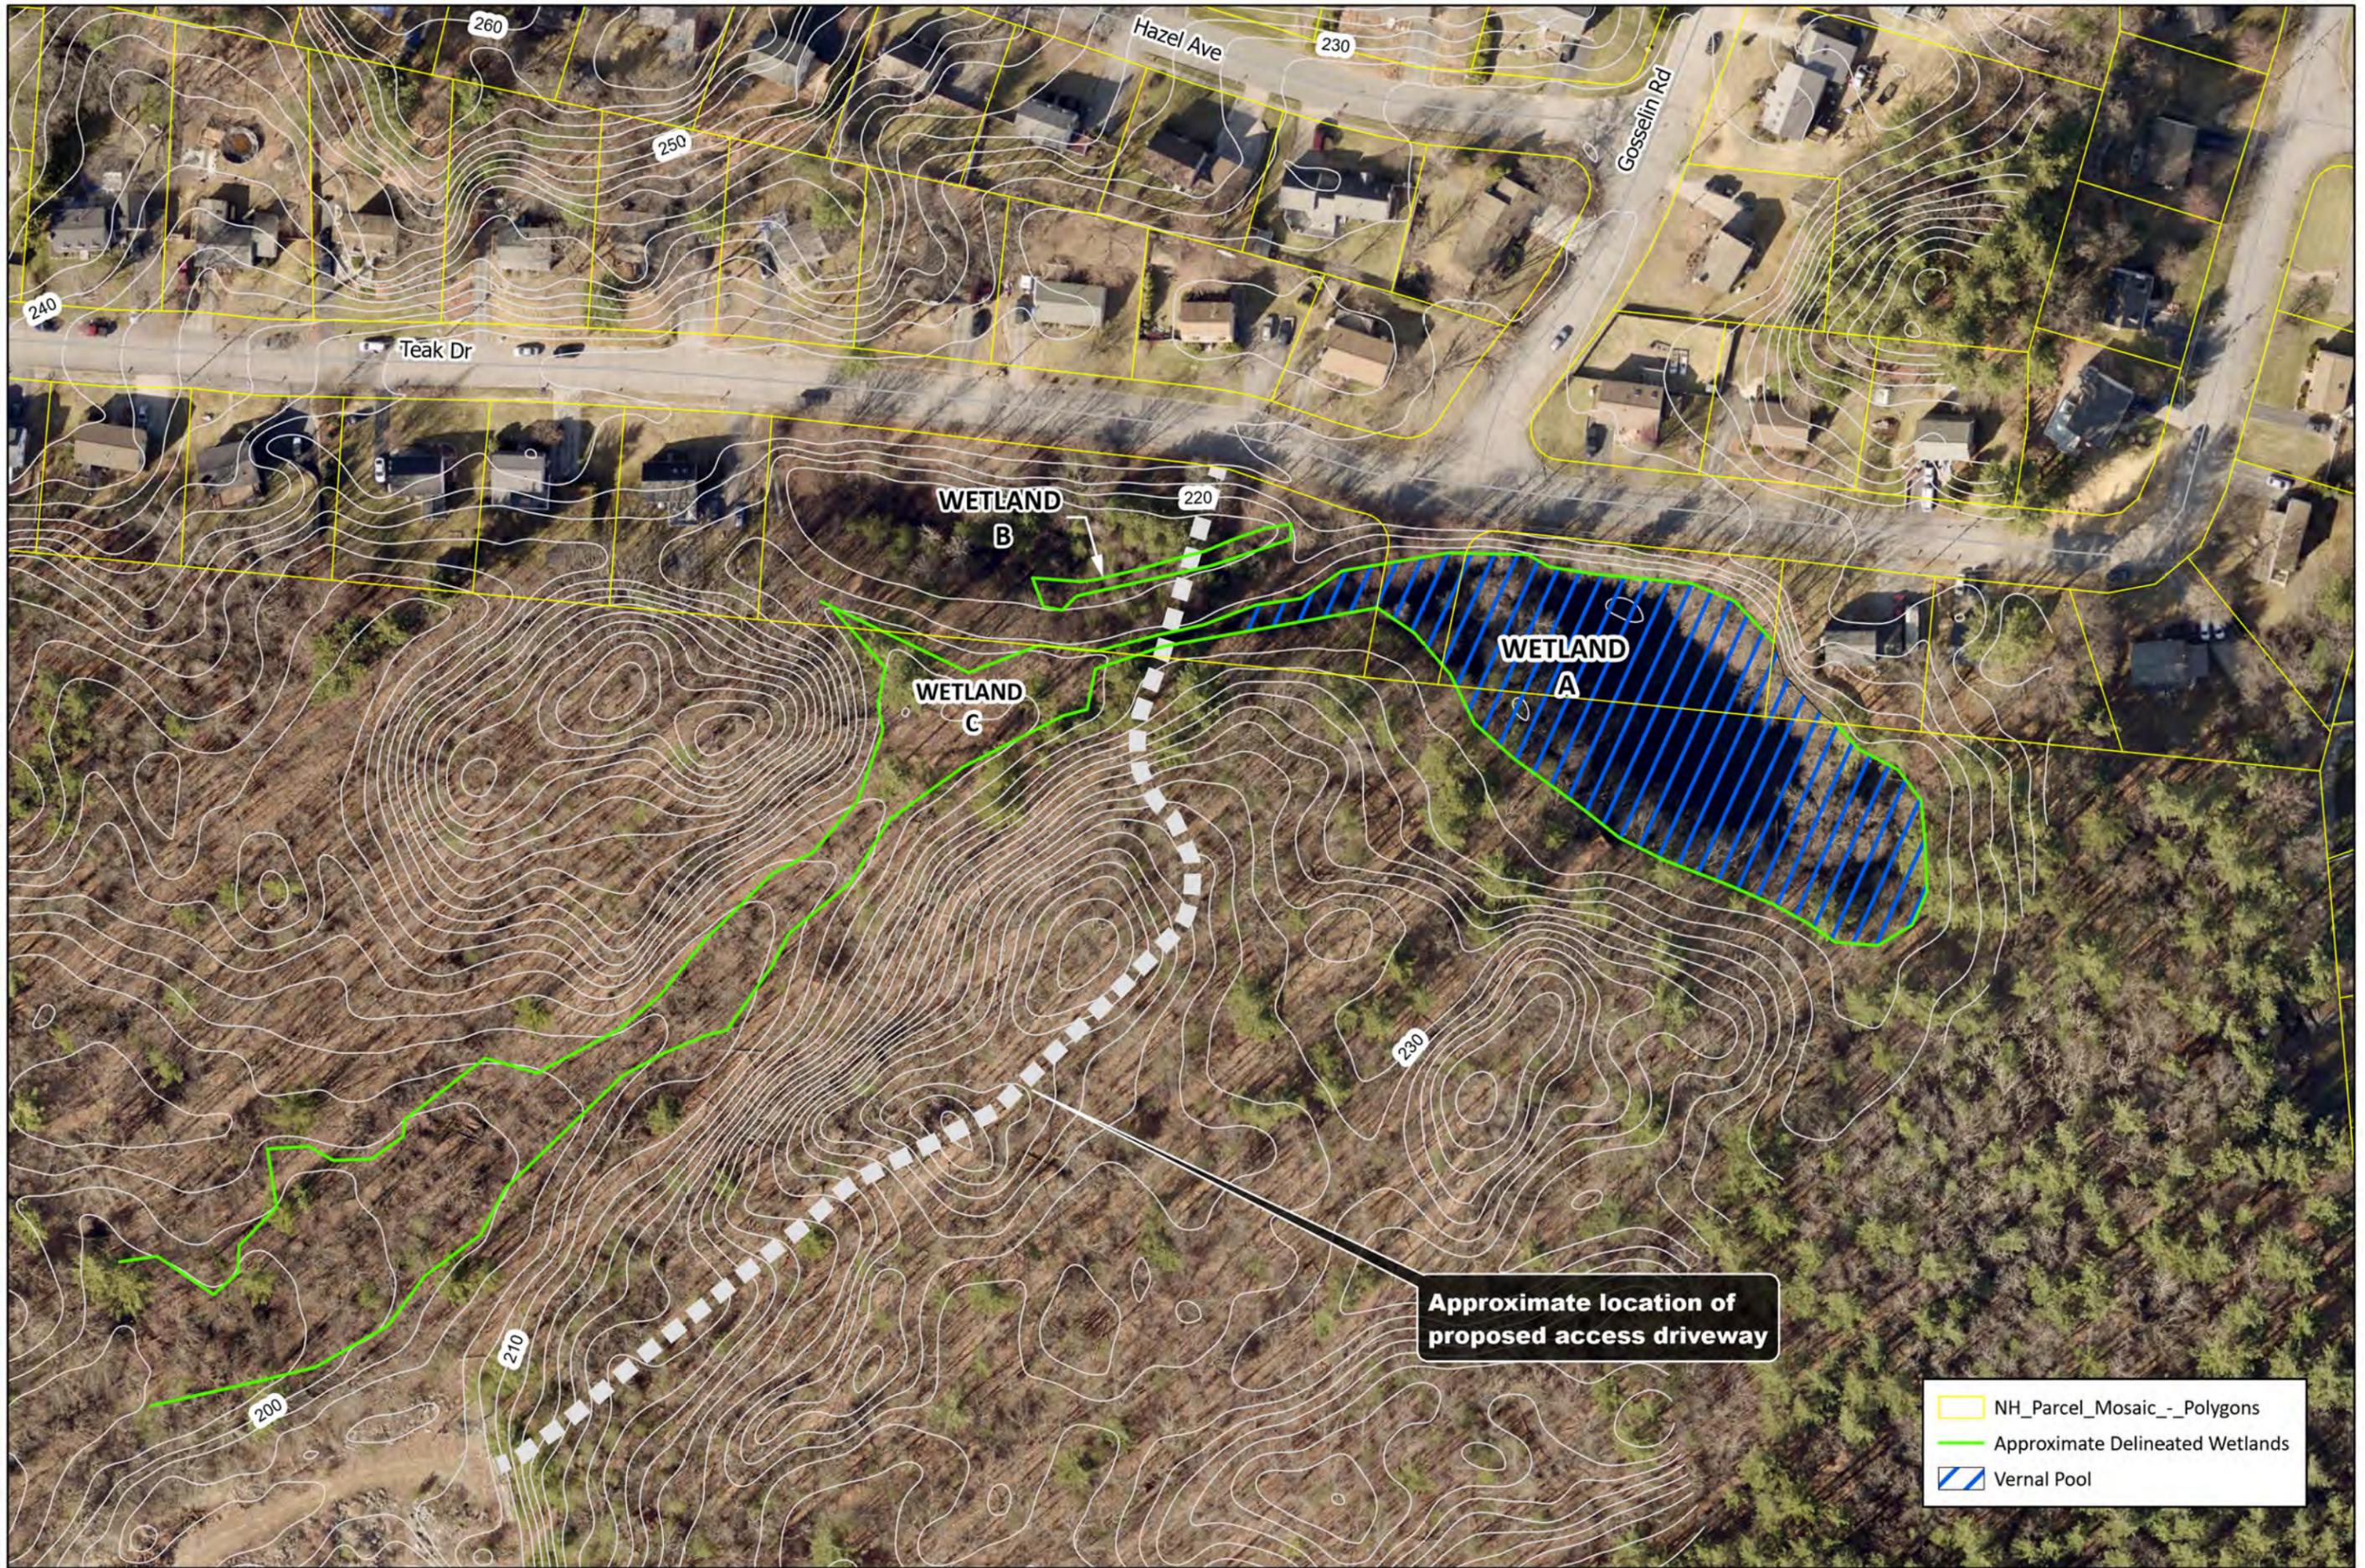
Approximate location of proposed access driveway

WETLAND B

WETLAND A

WETLAND C

The project Site consists of two distinctly different areas. The proposed location of the proposed firefighter training area is located at the edge of the landfill in a cleared and graded area currently used for material storage, recycling, and composting. The area extending east to Teak Drive through which the access driveway is proposed consists of is mature forest dominated by oaks. The wetland resources identified on the Site have been identified as Wetlands A, B, and C on the attached Wetland Overview Figure and described in the following sections.

This wetland lies directly adjacent to Teak Drive occupying a conspicuous depression situated between the road and higher grades to the west. The wetland consists of a shallow pond with a perimeter of scrub shrub wetland dominated by buttonbush and highbush blueberry. Water levels in the pond and adjacent vegetated wetland appear to fluctuate significantly throughout the year as seen on history of aerial photography and over the course of field work. The presence of buttonbush, a species which is well adapted to grow in near permanent inundation, suggests at least a portion of this wetland maintains a semi-permanent hydrology. The classification of this wetland is PUBF/PSS1F.

Wetland B is located within a basin that appears to have been created for the purpose of managing roadway drainage which enters the area from several outfalls. The majority of this basin does not meet wetland criteria. The narrow drainage path between the main outfall and the outlet pipe has, however, developed sufficient wetland characteristics to qualify as a wetland. The wetland is sparsely vegetated with a mix of young gray birch, silky dogwood, and graminoid species. The classification of this wetland is PEM2/PSS1Br

Wetland C lies downgradient from both wetland A and B which both drain to this wetland. It is a forested wetland dominated by red maple. An intermittent stream channel develops in the wetland downslope of Wetland A and the outlet pipes from Wetland B. The wetland continues outside the project area to the west. The classification of this wetland is PFO1E/R4SB4/5.

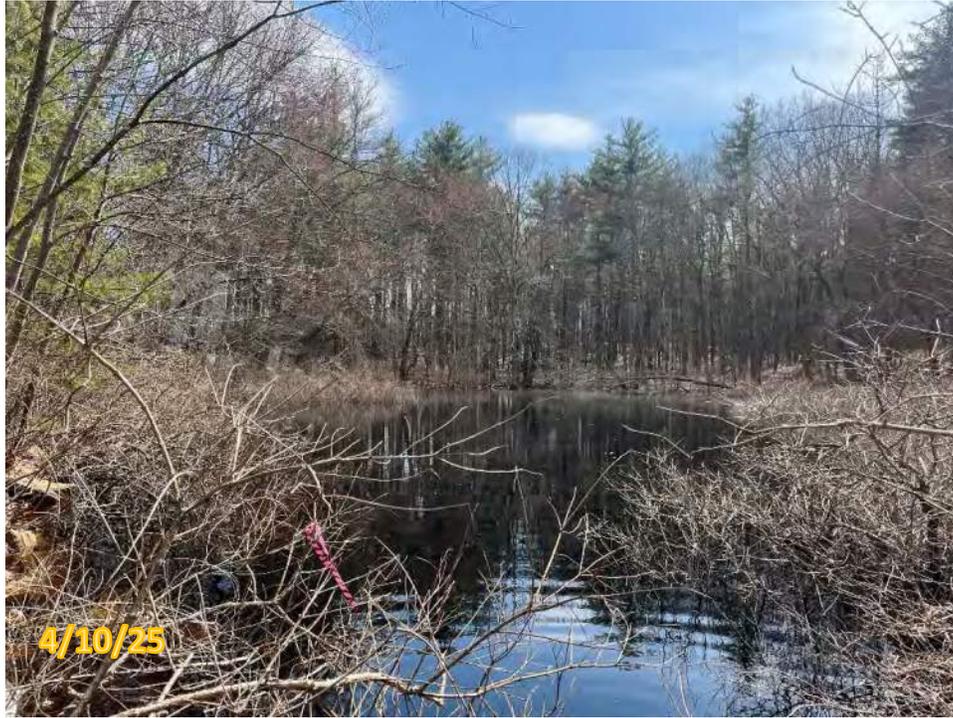
Photo 1 : Main area of Wetland A (vernal pool)

A single vernal pool was identified occupying the majority of Wetland A. The limit of the “full pool” extends up to a point in the narrow connection to Wetland B between wetland flags #27 and #77 where there was no longer any surface ponding. No egg masses were identified in this pool but the pool did contain an abundance of fairy shrimp which is a primary vernal pool indicator species. The depth of the pool, exceeding 4 feet in the center, and the dense buttonbush edge made survey of the pool difficult. It is therefore likely that additional indicator species are present in this pool but were not recorded by the survey. The data form and photographs collected during the survey are attached.

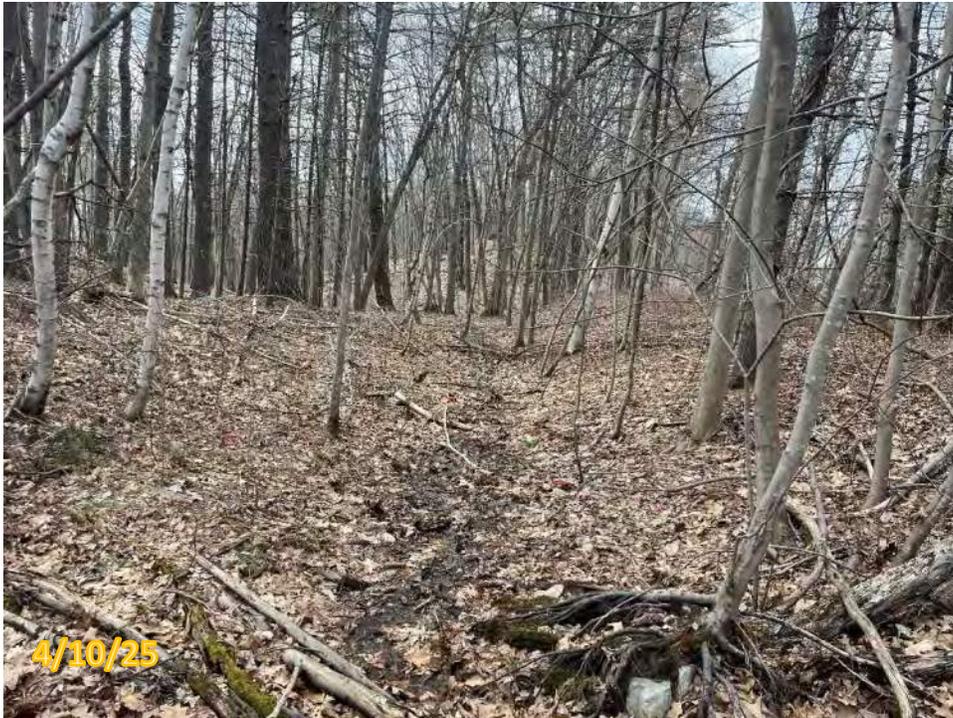
Photo 2: Narrow connection between Wetland A and Wetland C (impact area)

The hydrology of the wetland appears to be entirely supported by groundwater as no contributing wetlands, streams, or pipes were identified. The wetland does drain west into Wetland B via a narrow wetland connection. This hydrology in this location is not wetland semi-permanent like the pond, nor does it exhibit development of a channel as would be the case with frequent discharge. It's likely that the pond discharges only during the highest seasonal water levels. During inspection in April of 2025 this area was flooded up to the narrow wetland connection with no outflow.

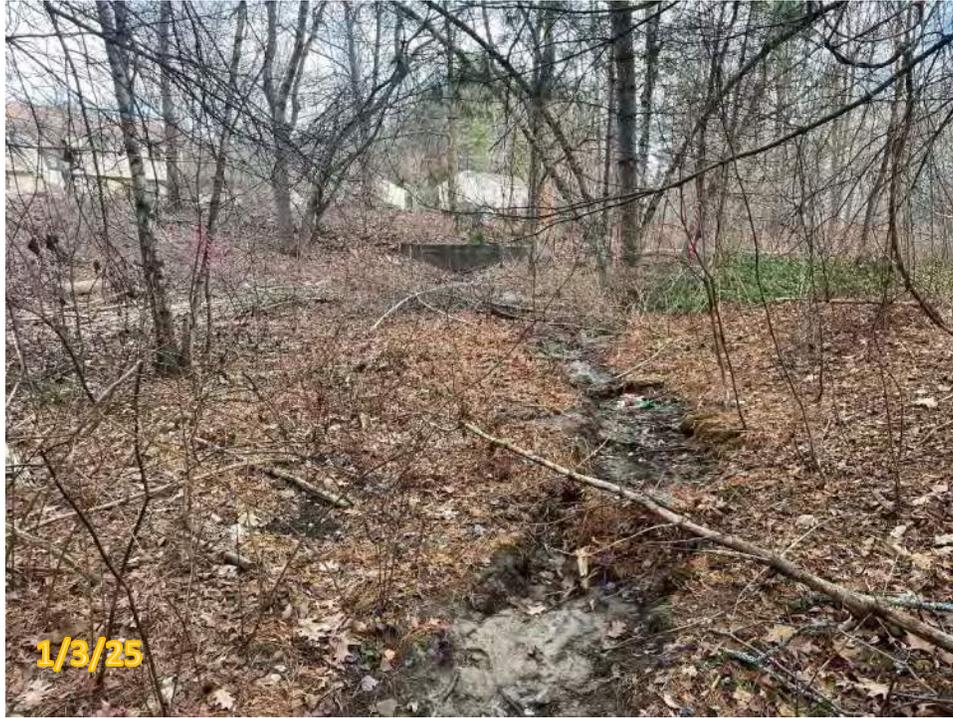
Photo 3: Looking upstream Wetland B (stormwater conveyance/Impact area)

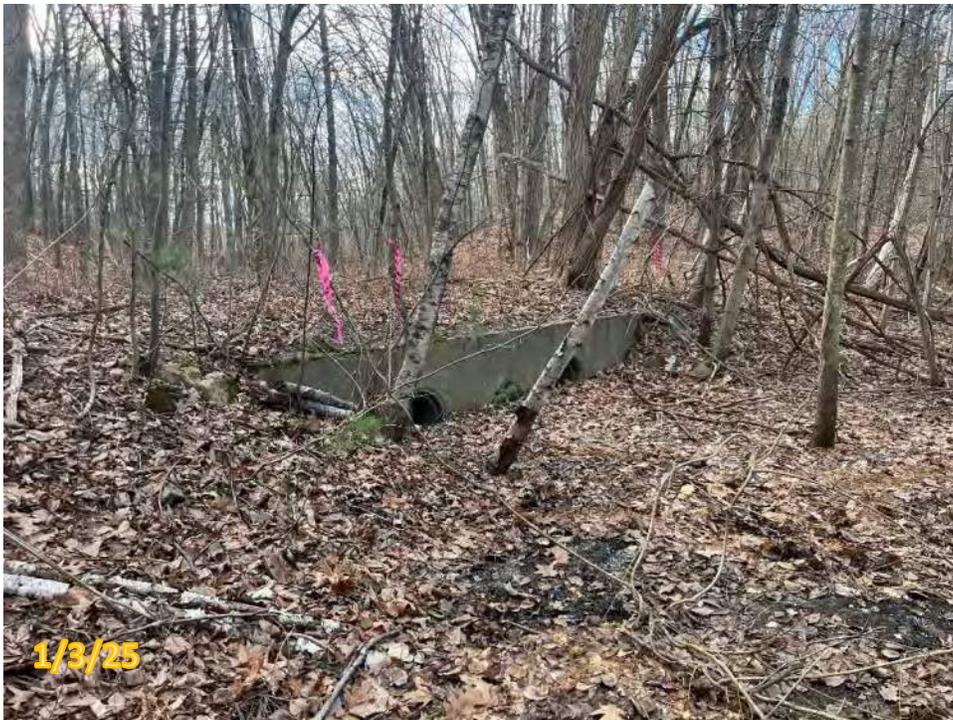
Photo 4 : Downstream end of Wetland B (stormwater conveyance/Impact area)

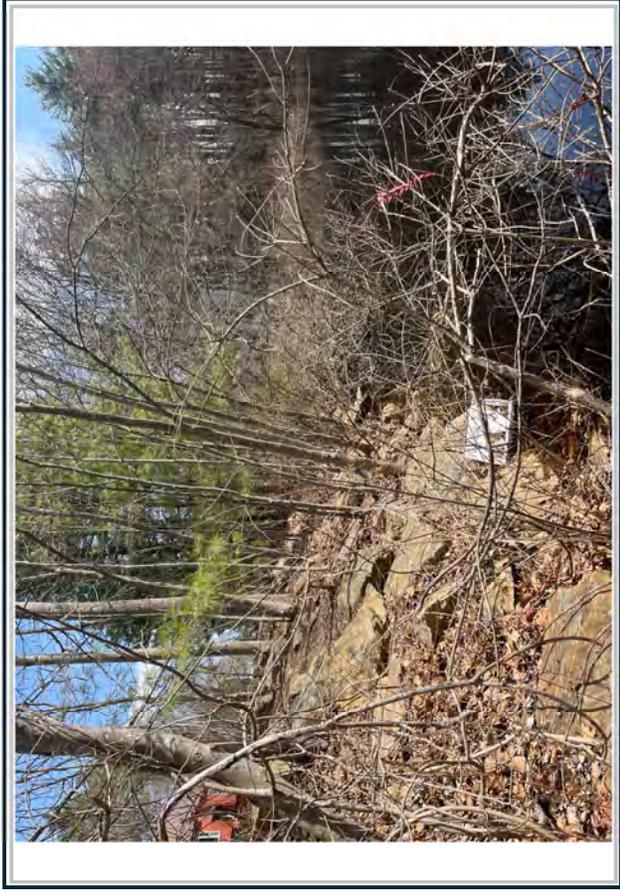
4/10/25--Boulder embankment along Teak Drive

Pool lies directly adjacent to Teak Drive at base of boulder slope

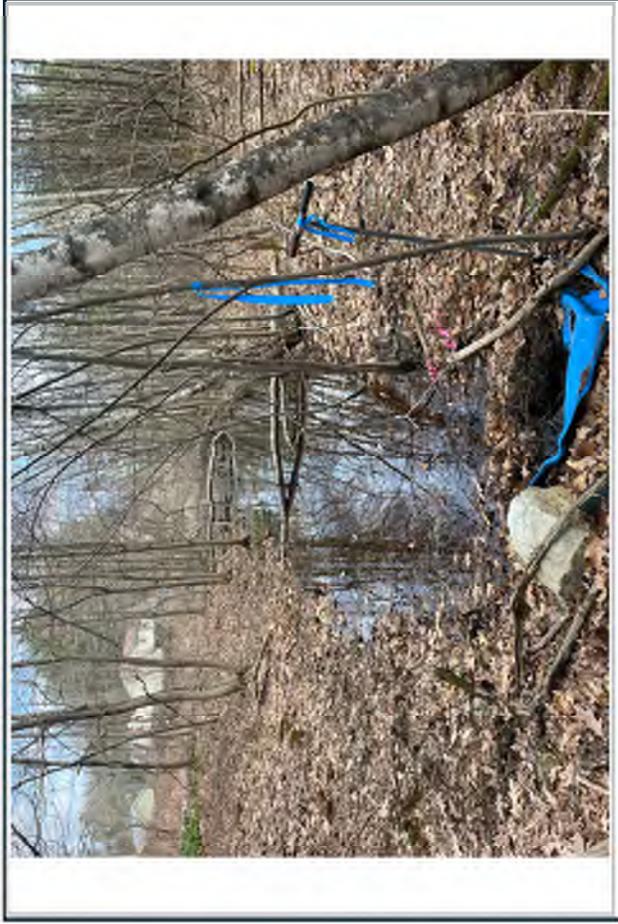
4/10/25--Looking up into the main part of the pool from its intermittent outlet

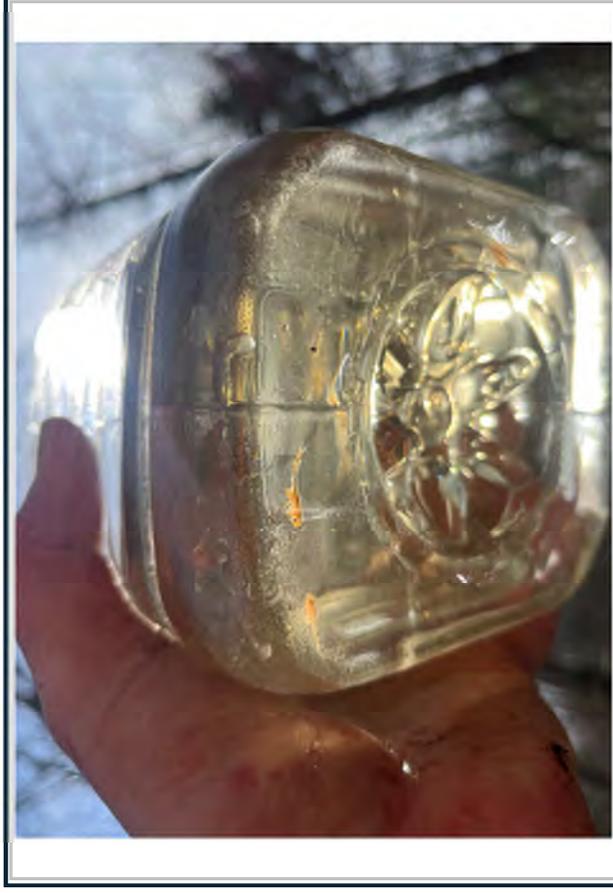
4/10/25--Fairy Shrimp are abundant in the pool

Species observed	Adults			Egg masses (#)		Tadpoles, Salamander Larvae and Transforming Juveniles	
	Seen #	Courtship/ amplexus (Y/N)	Heard Y/N	Counted	Estimated	Tadpole/ Larvae estimated	#Transforming juveniles (#)
Wood frog							
Spotted salamander			NA				
Marbled salamander			NA				
Blue spotted/ Jefferson salamander			NA				
Mole salamander (unknown species)			NA				
Fairy shrimp	Abundant	NA	NA	NA	NA	NA	NA

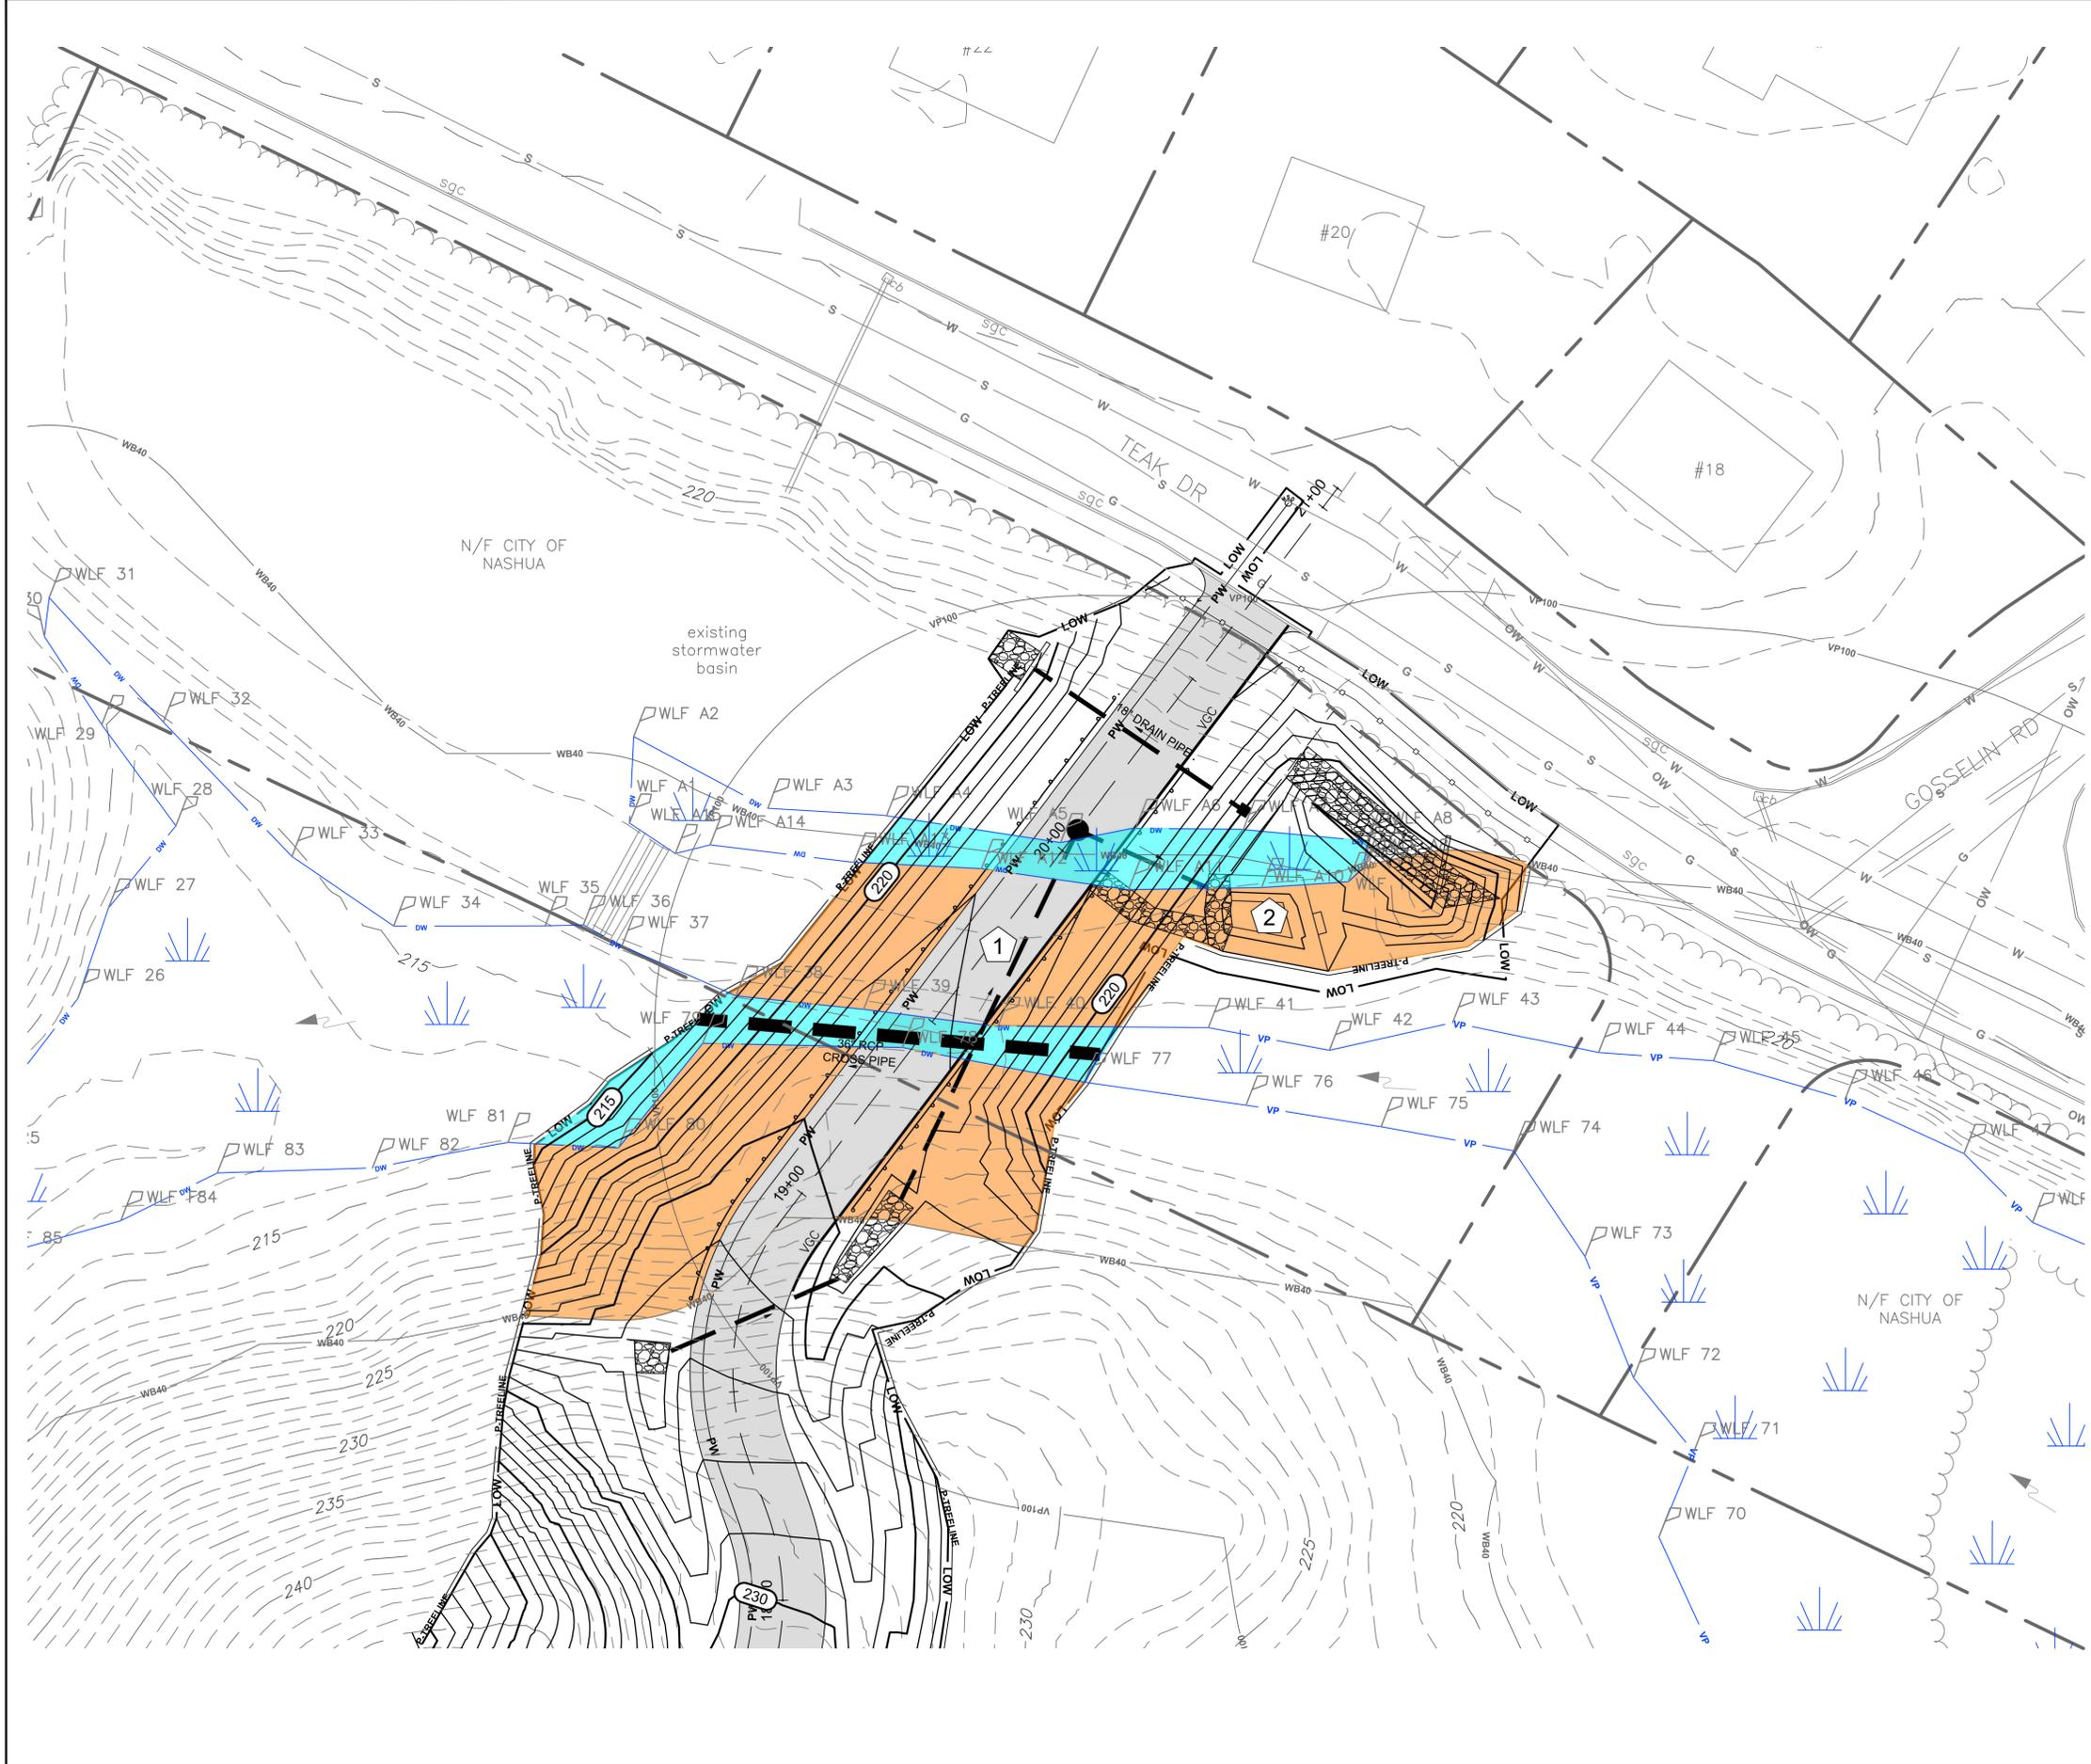
DRAWING NO.
W1.1
SHEET 1 OF 3

- 1 20 FT ACCESS ROAD
- 2 FOREBAY STORMWATER PRETREATMENT AREA
- WETLAND IMPACT AREA - 2,545 SQ-FT
- WETLAND BUFFER IMPACT AREA - 9,533 SQ-FT

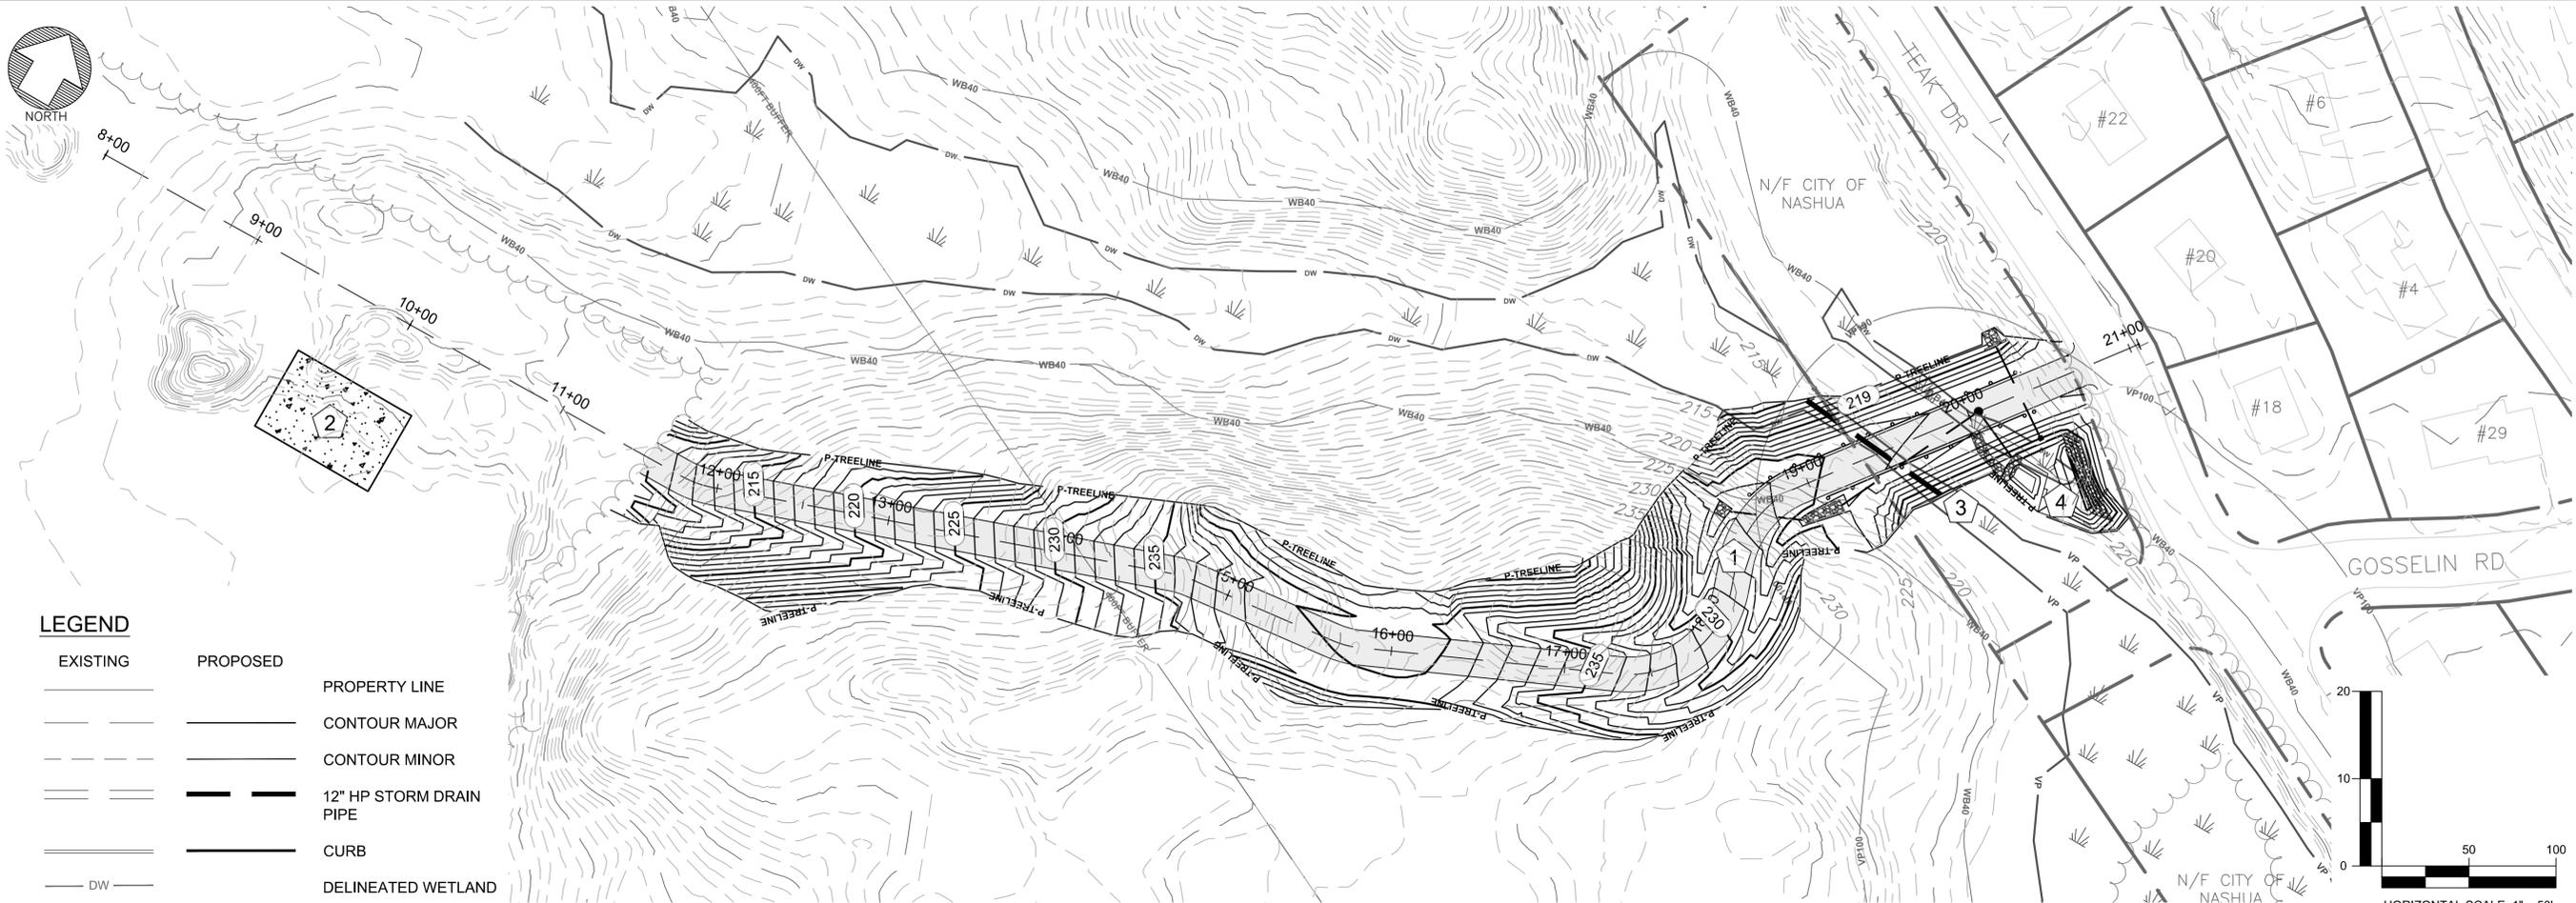
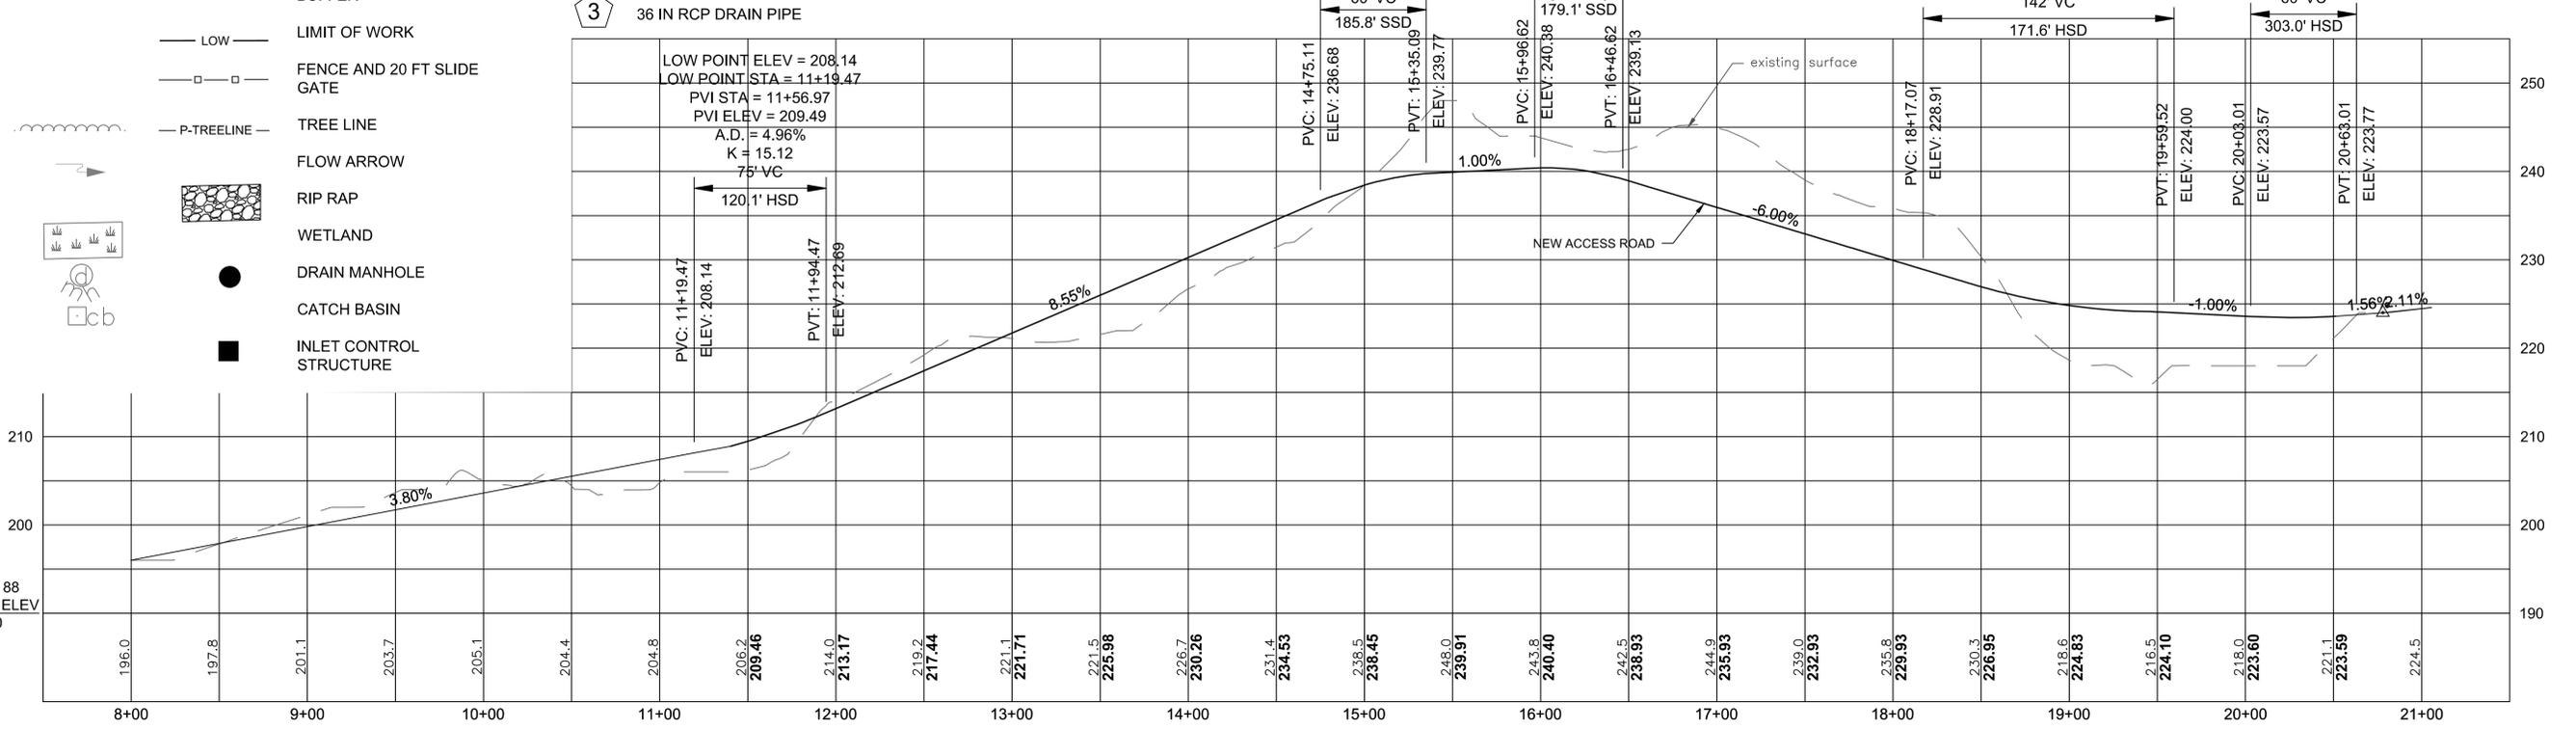
- 1 20 FT WIDE ACCESS ROAD
- 2 FIRE TRAINING FACILITY
- 3 36 IN RCP DRAIN PIPE
- 4 FOREBAY STORMWATER PRE-TREATMENT

HIGH POINT ELEV = 239.77 HIGH POINT STA = 15+35.09 PVI STA = 15+05.10 PVI ELEV = 239.26 A.D. = -6.92% K = 8.66 60' VC	HIGH POINT ELEV = 240.42 HIGH POINT STA = 16+03.77 PVI STA = 16+21.62 PVI ELEV = 240.63 A.D. = -7.00% K = 7.14 50' VC	LOW POINT ELEV = 224.00 LOW POINT STA = 19+59.52 PVI STA = 18+88.30 PVI ELEV = 224.68 A.D. = 4.98% K = 28.62 142' VC	LOW POINT ELEV = 223.46 LOW POINT STA = 20+25.48 PVI STA = 20+33.01 PVI ELEV = 223.27 A.D. = 2.67% K = 22.47 60' VC
---	---	--	---
